Mitigation of Savadkouh Landslide Using Non-woven Geotextiles

Abstract: Hazardous landslides are ordinary phenomena in north of Iran. In this paper, mitigation of a landslide in Savadkouh by using non-woven geosynthetic was investigated. Reinforced slope was designed using limit equilibrium analysis and numerical method such as those based on the FHWA guidelines and finite element method and with in-situ residual soil. The main goal of this paper in designing a reinforced slope instead of failed slope is finding number of reinforcement layers and vertical distance of reinforcement layers. Using the non-woven fabric to repair failed slope is a good option to prevent respective failures. When the non-woven fabric is used, it not only generates the tension forces to enhance the overall stability of slopes, but also prevents the development of pore water trapped in clayey soils by providing horizontal drainage through the fabric. Results of analysis showed that positive effects of reinforcement are clear and lead to decrease of horizontal displacements.

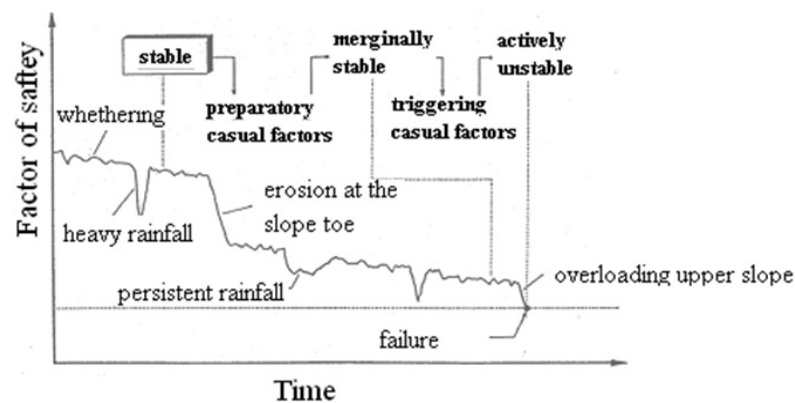
Fig. 1: An example of changes in the factor of safety with time.

In every slope there are forces which tend to promote down slope movement and opposing forces which tend to resist movement. A general definition of the factor of safety, F , of a slope results from comparing the down slope shear stress with the shear strength of the soil, along an assumed or known rupture surface. Starting from this general definition, (Terzaghi, K. 1950), divided landslide causes into external causes which result in an increase of the shearing stress (e.g. geometrical changes, unloading the slope toe, loading the slope crest, shocks and vibrations, drawdown, changes in water regime) and internal causes which result in a decrease of the shearing resistance (e.g. progressive failure, weathering, seepage erosion). (However, varnes, D.J. 1978), pointed out there are a number of external or internal causes which may be operating either to reduce the shearing resistance or to increase the shearing stress. There are also causes affecting simultaneously both terms of the factor of safety ratio. Fig. (1) Shows an example of factor of safety variation as a function of time, for a given slope and Table 1 and 2 shows brief lists of landslide casual factors and remedial measures.

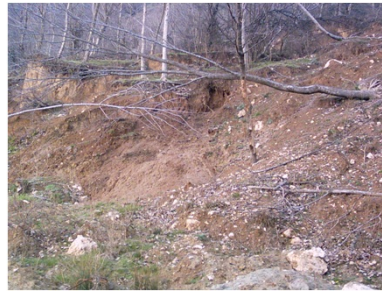
Fig. 2: Scarp of Flourd landslide with tilted trees

The site is located at Savadkouh Azad University grounds in the rural surroundings of Savadkouh, 5 Km from Pol-Sefid city in the north of Iran. The elevation of the site is 350 m above sea level and like the surrounding lands, a forest vegetation cover and a mountainous morphology is dominant. Fig. (2) Shows a scarp of the landslide along with the tilted trees at indicating the extent of the slide.

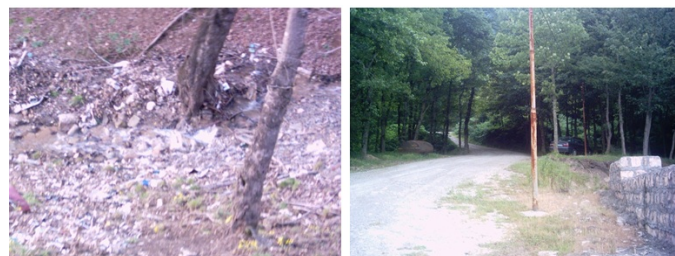
Fig. 3: Access road to the site and the high seepage flow of 10-20 liters per second observed.

As previously mentioned, the slide mass at the university site is part of a sliding slope facing the south eastern direction. The sliding mass extends to the calcareous sediments on the south west side, and to the river at the foot. Steady state seepage passages through the medium and above the level of the rock foundation. A volume of 15 to 20 liters per second were predicted for these seepage flows. The slide mass does not have any visible surface flow paths and the existing paths are rather scattered in the whole region (Fig. (3)).

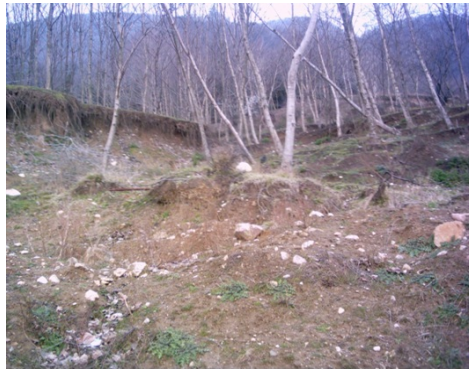
Fig. 4: A view of the active slide at the site – tilting trees and visible roots indicate an active fault in the area.

The upper surface of the slide is has a concave form which gathers rainfall water into the sliding mass. Therefore, each period of heavy rainfall caused a reactivation of the slides. Tilting of the existing trees indicates that a creep type of active slide is dominant in the area (Fig. (4)).

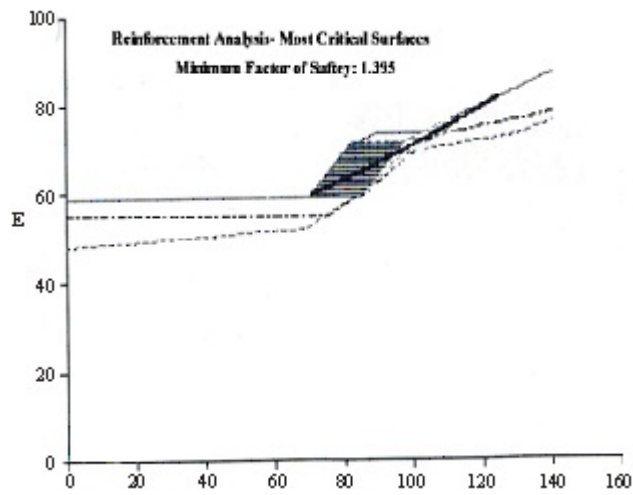
Fig. 6: Initial design of reinforced slope for 1.5:1 slope

Limit equilibrium analysis was first performed on the section chosen, in order to observe the possible failure mechanisms of the slide, as well as to suggest a design for the reinforced soil slope intended to mitigate the landslide. An initial analysis was performed in each case in order to evaluate the factor of safety of the slide section. Then, the design section of RSS was used to give a suitable design for a reinforced soil slope in order to mitigate the landslide. A factor of safety of 1.4 was considered adequate for conditions of equilibrium. The reinforced slope was extended into the bedrock in order to prevent failure surface from developing through the interface between the reinforced mass and bedrock. Figs. (6–9) show several RSS model analysis results, which show design outputs for the reinforcement based on FHWA guidelines. It is clear from the results that a reinforced slope is adequately capable of mitigating the landslide. Tables (4) and (5) list the parameters used for the RSS calculations and finite element model. Also, the results of the limit equilibrium analyses are tabulated in table (6).

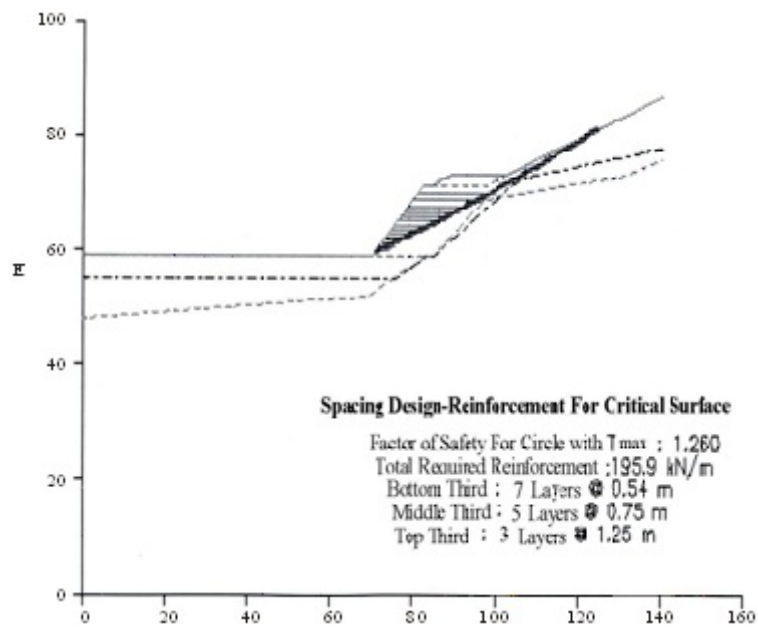
Fig. 7: RSS design output for 1.5: 1 slope

| Reinforced Slope | | Initial Design | | Unreinforced slope | Slope Angle |
|---|---|---|---|---|---|
| 4@1.06m 3@ 1.1 8m 3@ 1.43m | 153.1 m/m | 1.443 | 1.812 | 1.306 | 1.5:1 |

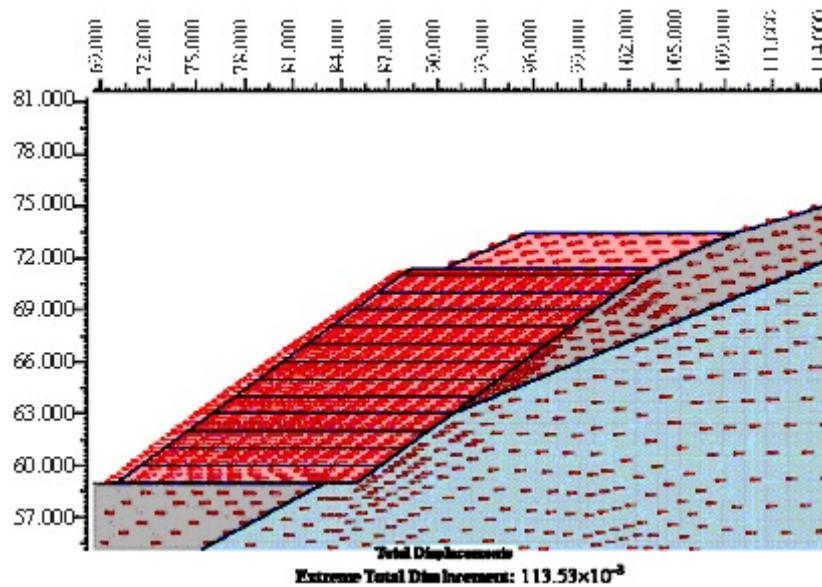
Fig. 11: Extreme total displacement vectors in the reinforced slope mass

Maximum displacements in the reinforced slope were obtained as 11.4 cm, which is equivalent to % 0.9 of the slope height. Total displacement vectors are shown in Fig. (11) which shows a maximum displacement of 0.3 cm.
